PLOT 123 NEWBURY DRIVE

Snagging Survey

Sample Report

Project Details

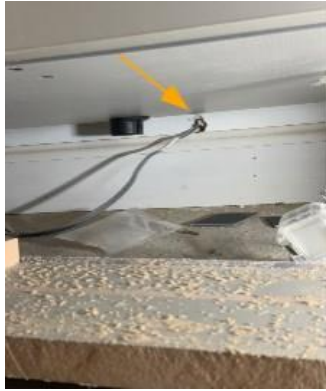
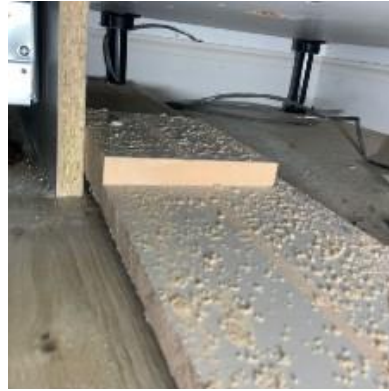
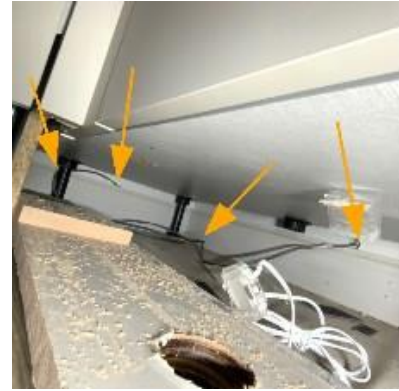
Electrical cable to under kitchen cupboards

Description: Under kitchen units, electrical cable enters through back wall without use of junction box, is draped around the floor, is excessive in length, coiled in position increasing current draw, wrapped around the unit base feet and enters the adjacent wall behind the skirting without a suitable junction box.

BS7671 NICEIC guidance for installation to 18th edition .
Electrician should be consulted to re-route and ensure a suitable installation to comply with current standards and best practice throughout, without live cables being left exposed under cupboard spaces.

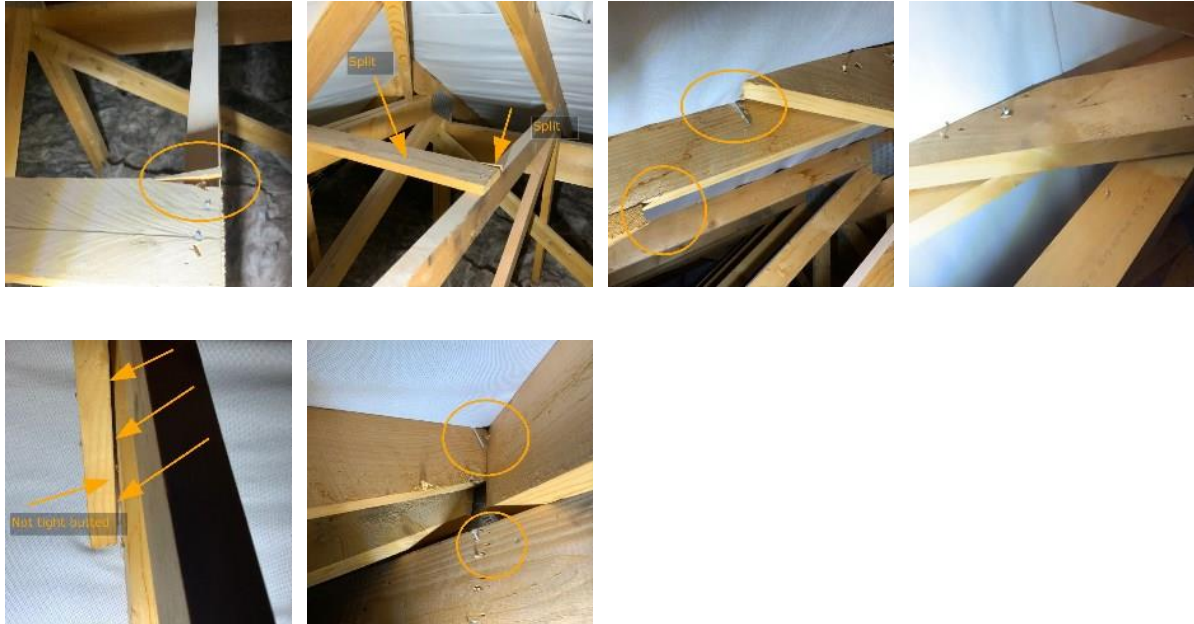
Loft bracing

Description: Rafter, truss members and joints not fully aside , Nails protruding splitting members and weakening the structure. Nails not fully driven home.
Joints not tight butted.
Split bracings, and nails general note throughout loft space creating a weakened structure, should be driven home and ensure all jointing plates are suitably affixed together with battens and braces.

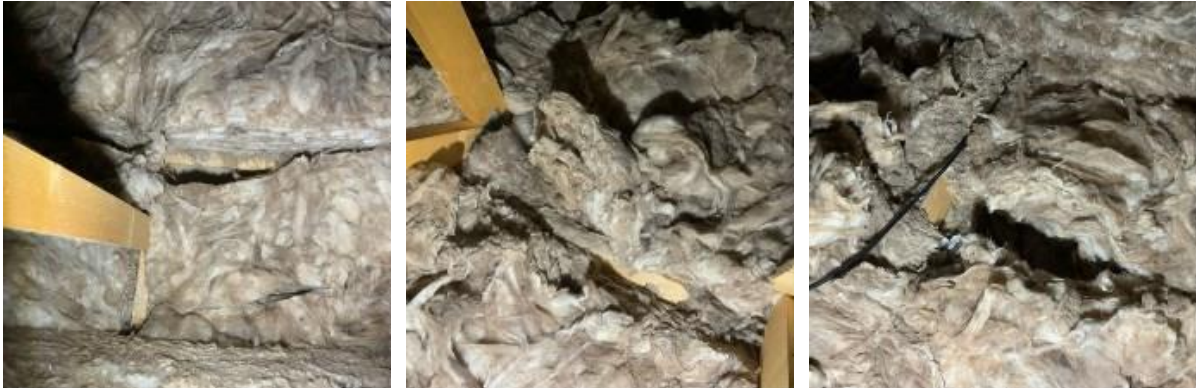
Description: Loft insulation is not to the relevant depth locally, nor is it adequate in its installation.

Scottish Building standards 6.2.1

BS EN ISO 6946:2007 (U Value Calculation) is unlikely to be met noting a loss of thermal performance due to the nature of the omissions and inconsistencies noted .
Installation of thermal insulation BRE GG68-1 & 2 (good site practice)

1. Compressed areas reducing depth
2. Localised omissions
3. Fixtures and fitting not abutted
4. Gable and eaves not fully abutted.
5. Thermal bridging to perimeter / ceiling interface particularly at locations whereby insulation requires attention (cavity closers should be further checked for fitment)

All upstairs areas during thermal imaging have exhibited excessive thermal inconsistencies throughout (refer to thermal report's)

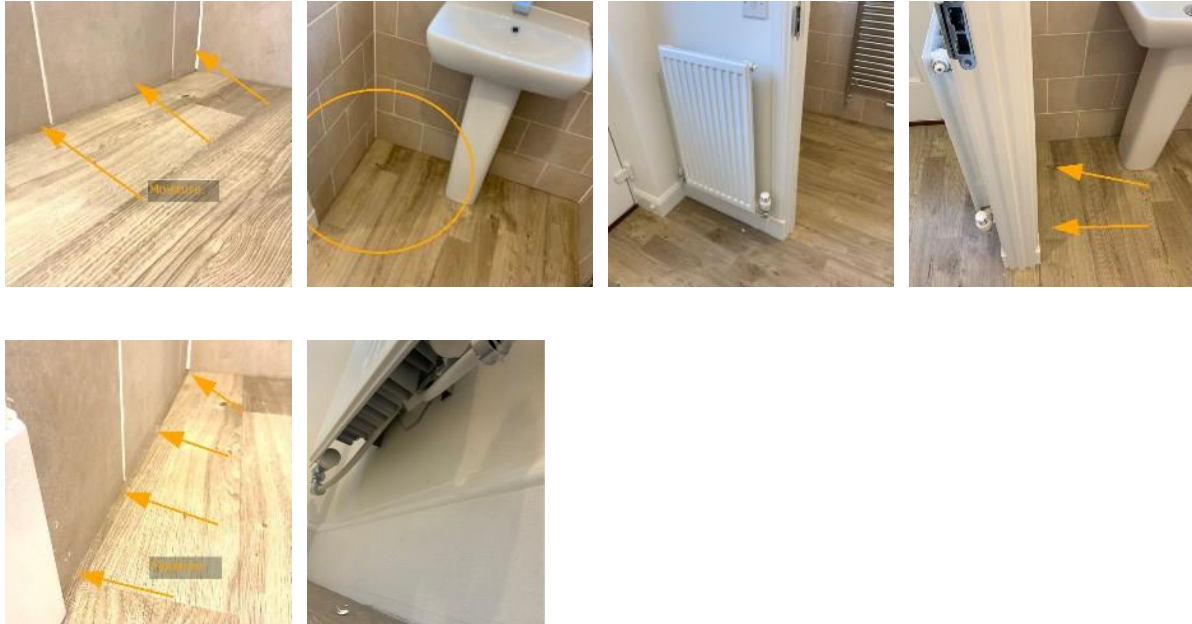
Downstairs toilet moisture / leak detected

Description: Moisture Leak detected at floor level.

Management of moisture in buildings BS5250 / Code of practice for control of condensation and BRE DG 245 rising damp

On assessment, thermal imaging revealed significant moisture accumulation to the areas abounding the partition wall between the toilet and the utility room rear door, with radiator fitted.

It is further noted that the inlet / outlet are both located within the region of the moisture accumulation.

Moisture is locally collecting at the interface with the floor tile and plasterboard wall.

Invasive works are required to locate the source of the leak / moisture accumulation .

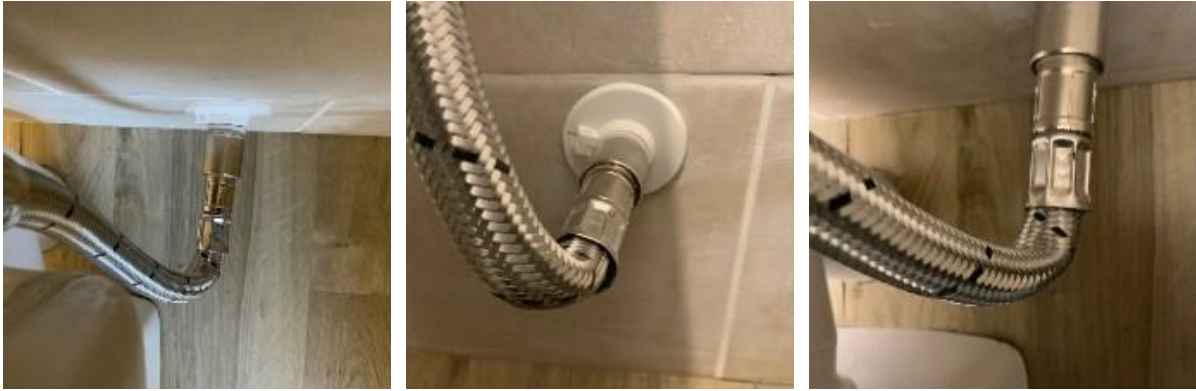
Downstairs toilet - inlet water - kinked

Description: Kinked flexible pipework is not permitted as per HSG 274- Part 2 - ACOP L8 in the prevention of legionella.

Flexible pipe to be suitably altered to remove kink and reduce increased risk of legionella macro growth within the kinked pipe.

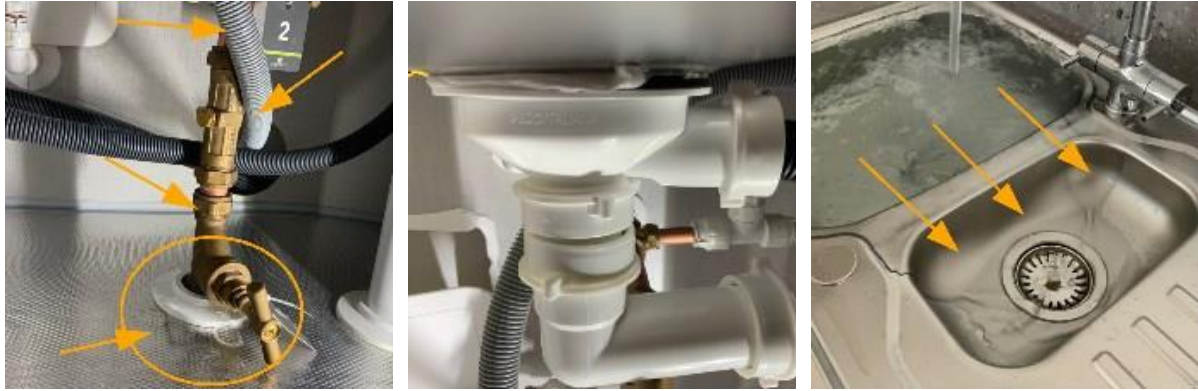
Kitchen under sink leak

Description: Leak observed tracking down waste outlet pipework under sink during testing.

Following filling of the sink, it was clear that the overflow is incapable of dealing with the flow volume from the tap, thereby creating a potential flood, should the kitchen sink overflow, given that the secondary basin has no overflow. The sink would therefore overflow and flood the kitchen in this regard.

It is suggested to ensure that a suitable overflow is installed within the primary and secondary sinks to prevent flood risk.

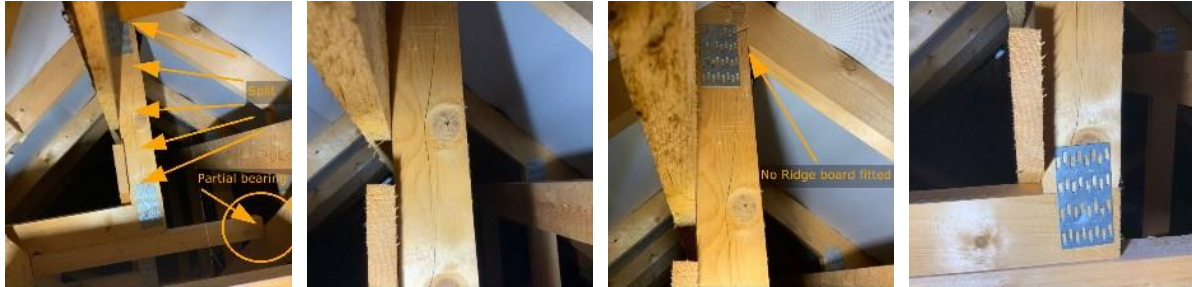
Split structural member

Description: Structural roof truss member split

Timber should have been rejected, defect is severe enough to warrant rejection in its entirety to the damaged post.

Bearing load path appears to be compromised through

Supports and fixings not fully bearing to gable area.

CRITICAL : - The load should be temporarily supported whilst a repair is effected.

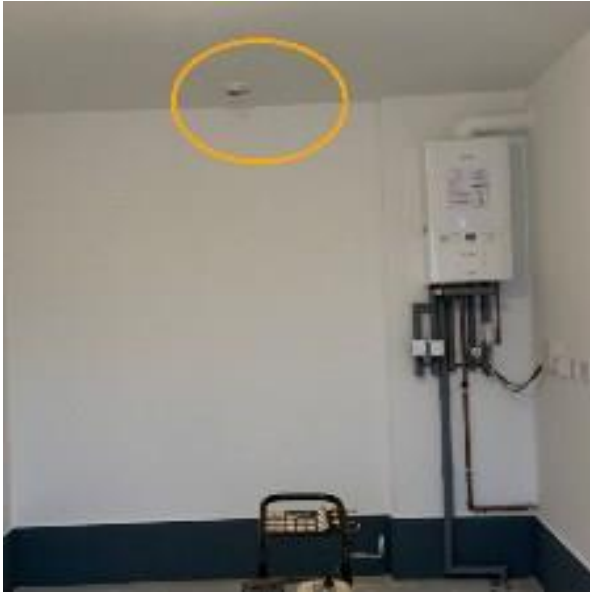
Garage- carbon monoxide alarm missing

Description: Carbon Monoxide alarm missing from garage . Electrical base fitting only, no alarm in place.

It is a requirement to have a carbon monoxide alarm fitted to the room / location where a gas appliance and or boiler is in place. GSUIR (Gas safety (Installation and use) Regulations 1998).

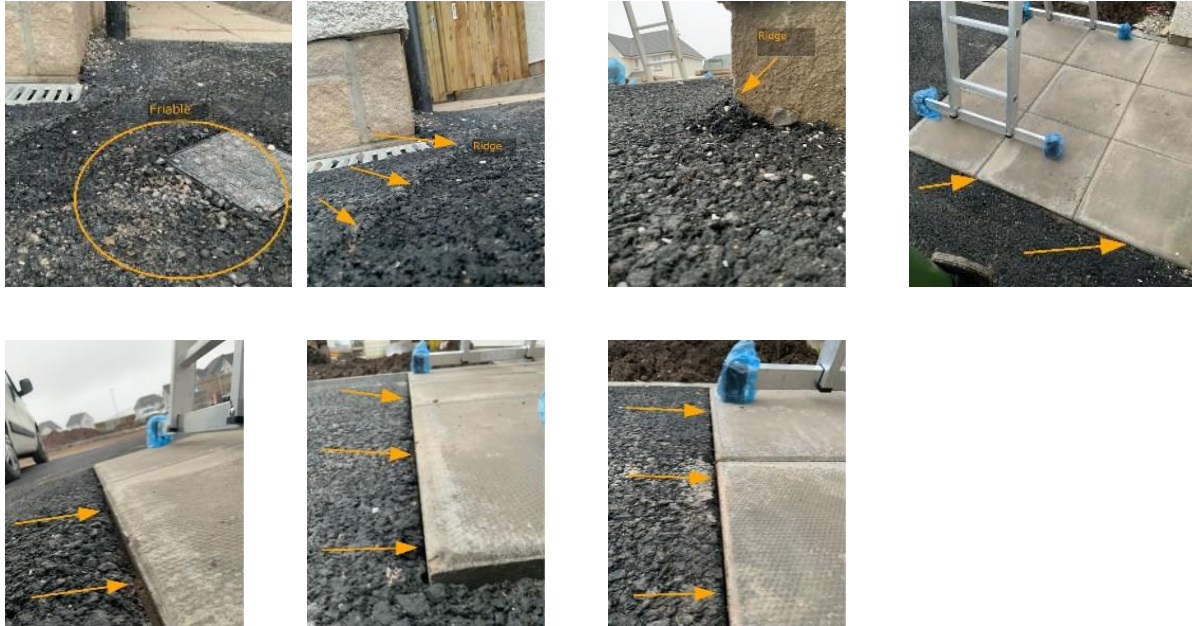
Tar to frontage / Slabs

Description: 1. Compaction plant / temperature of surface course inadequate at time of laying, leaving ridges, friable areas abounding Toby's, levels undulating locally, where by ponding is likely to collect around the Toby, local alterations should be made, heating and tamping to a suitable finish to achieve the desired performance specification.

2. Slabs cut into tar following surface course placement, leaving undesirable gaps abounding the slabs, water is likely to enter the joints and cause early deterioration through freeze thaw cycles, breaking up the tar locally. (Should be carefully and suitably sealed with a proprietary sealant) such as Fosroc Colpor priming with Fosroc Primer 19 or similar.

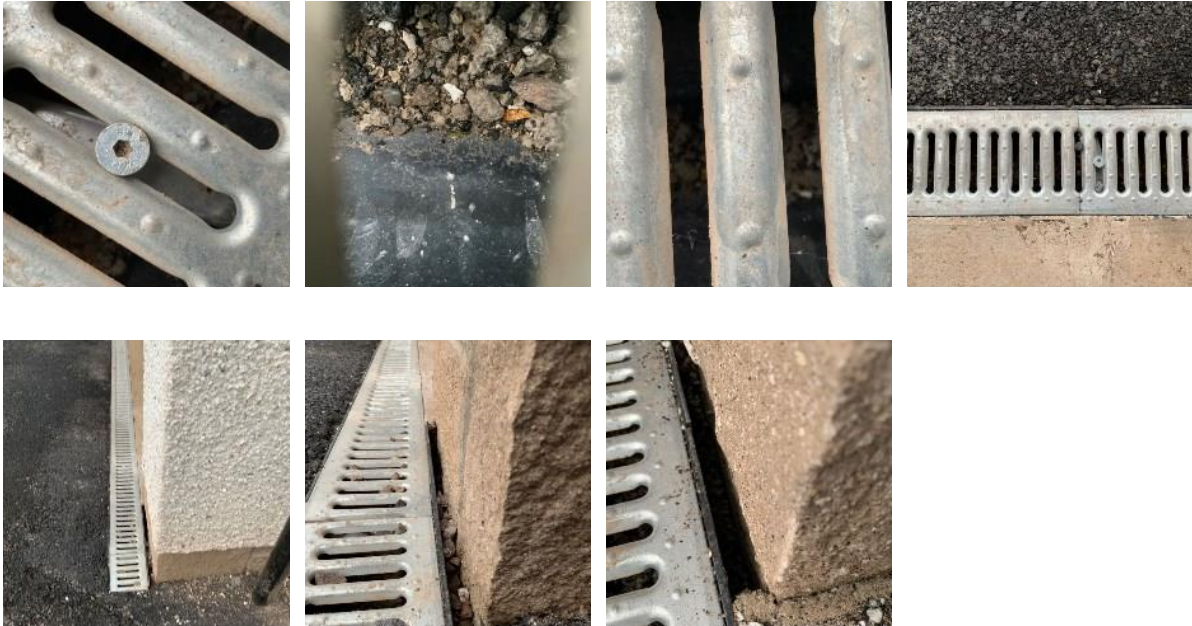
Garage - channels

Description: 1. Joints to channels excessive between brick and drainage channels, should be suitable filled as appropriate to prevent water and moisture build up against the perimeter of the building. Ensuring water is not trapped between the concreted channel base and the building fabric.

2. Channels require to be fully cleaned and flushed.

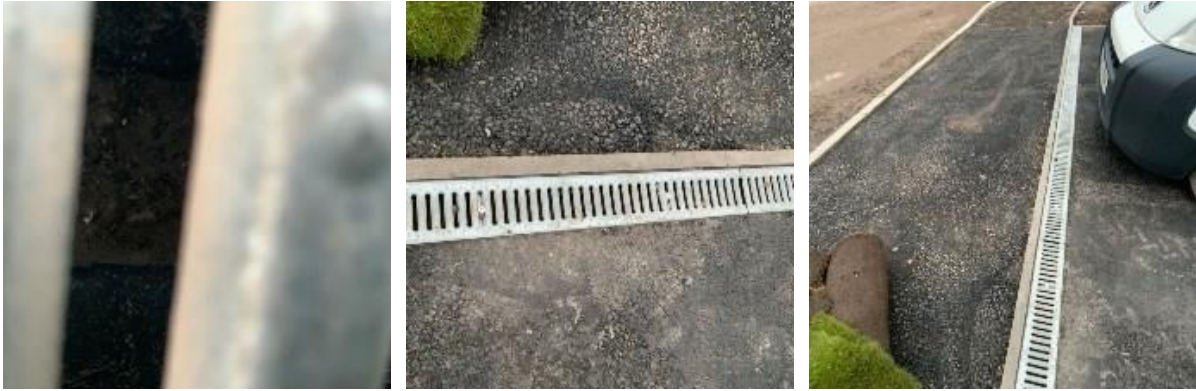
Drainage Channels to footpath delineation

Description: Drainage channels requires to be cleaned out and flushed throughout to be free flowing without sediment or construction debris within channels.

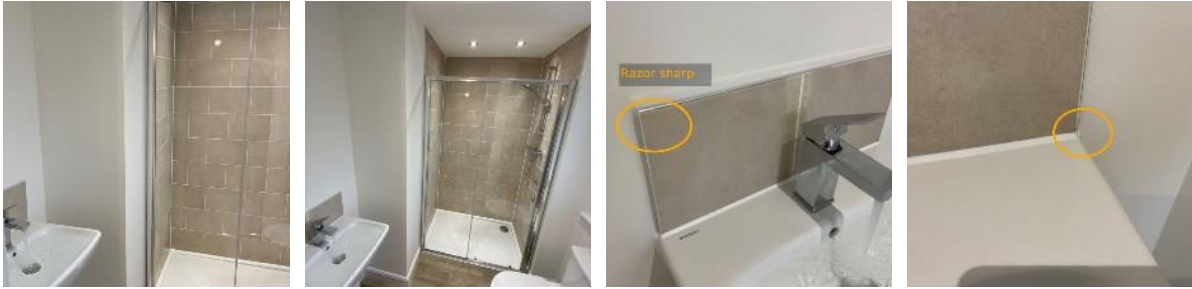
Master En-Suite beading

Description: Beading abounding tiles to sink has sharp edges. BS 8000- 11 wall and floor tiling.

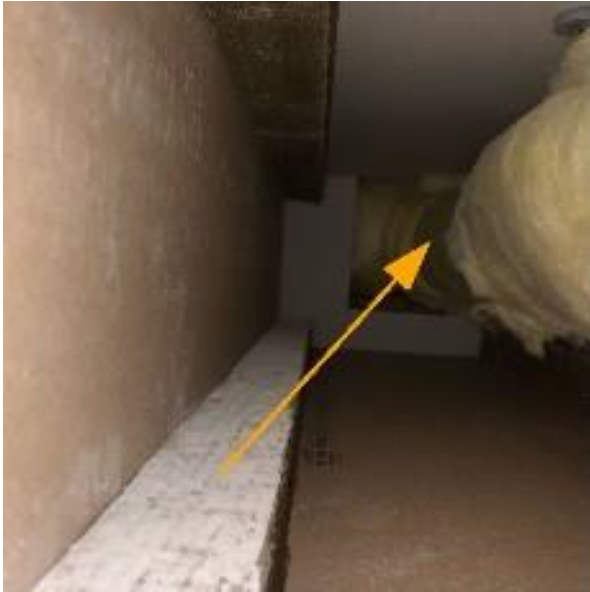
Sound insulation missing around junction of pipe at front door area near to level 01

Description: Scottish building standards Technical handbook - 5.1.7

Drainage and ventilation nuisance noise to have suitable sound insulation throughout.

Suitable subbing insulation should be provided around the joints and pipework throughout areas , particularly those adjacent to areas where sleeping is undertaken.

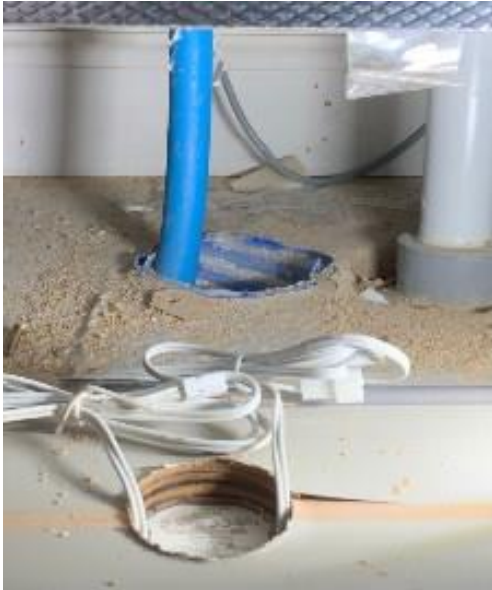
Sink - services - inlet

Description: Water services not sealed, to prevent unwanted cold airflow, vermin and insect access / egress.

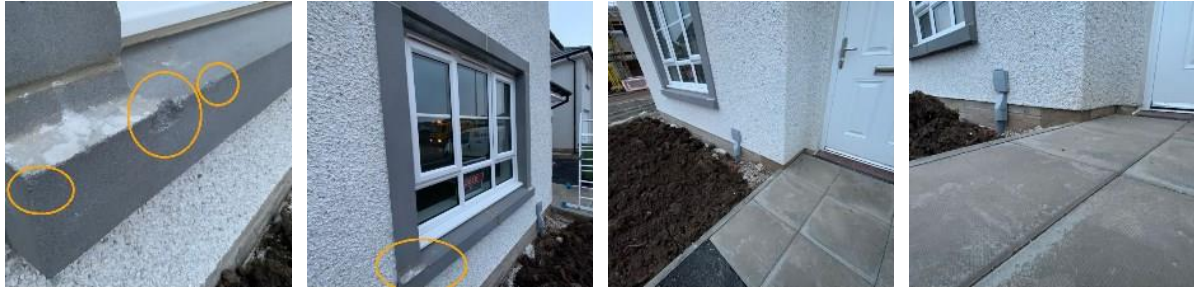
Sill chipped

Description: Sill chipped, to be repaired with proprietary patching compound following manufacturers recommendations for bonding and preparation.
Sill to be further painted as advised during visit by site manager.

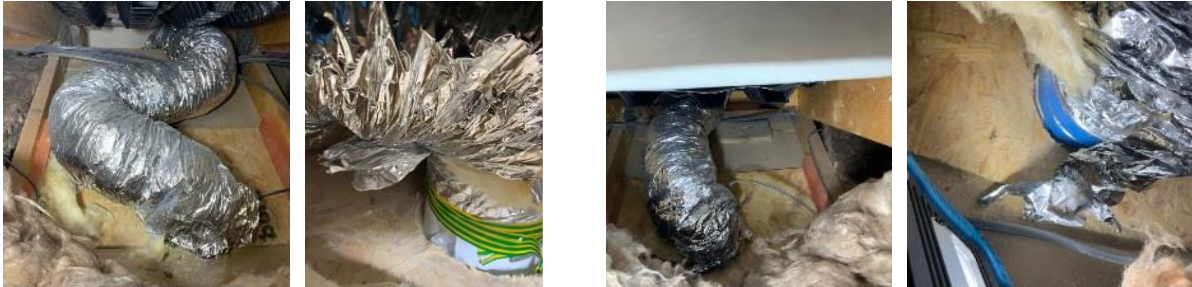
Extractor Fans Ducting in Loft Space

Description: Scottish Building Standards, Domestic Ventilation (Section 9 Ductwork)

Visible extraction ducts are flexible pipe, Scottish domestic ventilation building standards require that taught duct is used mechanically fixed in position, that the duct be supported in its length, the duct should not be sagging and collapsing under its own weight nor should it have numerous bends reducing flow rate.

The duct should not be raised toward the outlet and should be appropriately connected at each end, the duct should be insulated to protect against condensate due to the variance in temperatures, the insulation laid atop further compresses and reduces flow.

Disconnection is likely due to the fixing mechanism (electrical tape) - Moisture buildup within the roof space is likely due to the poor connection or disconnection of duct / axial fan unit, particularly local to the outlets of fans not connected or where backfalls exist long term deterioration is likely together with formation of damp and mould affecting end users.

The duct should be adjusted to be taught along its length supported to a level which allows for a run down to the outlet (typically to the eaves), consideration should also be given to a condensate trap as the current configuration permits vapour condensate to trickle back to the room from where it originates within and around the electrical fan unit.

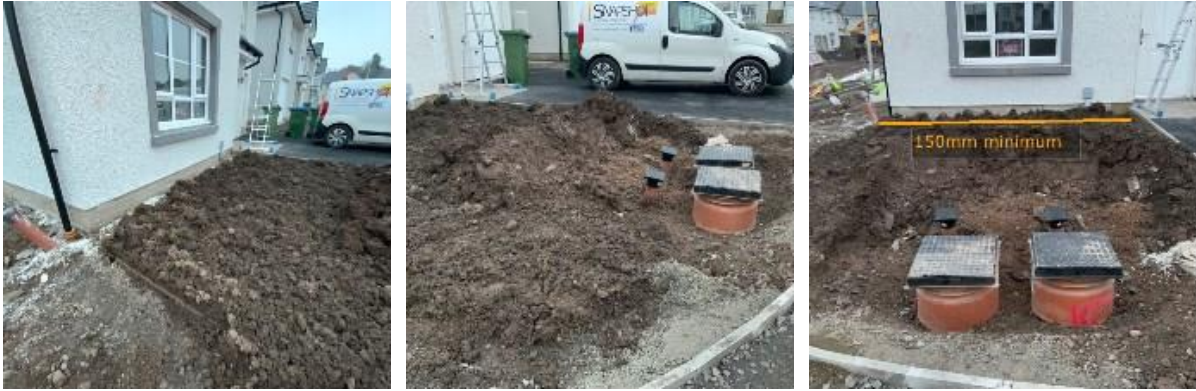
Unfinished drainage / topsoil and turf

Description: General unfinished landscaping, drainage covers.
Topsoil levels to be set to finished floor -150mm to ensure DPC not breached.

Inspection chamber covers and rod points to be set to profile of finished ground level.

Topsoil levels to be maintained at 300mm including subsoil and be de-compacted by rotovating to that depth, 100mm depth of suitable topsoil to be overlaid throughout. BS 3882

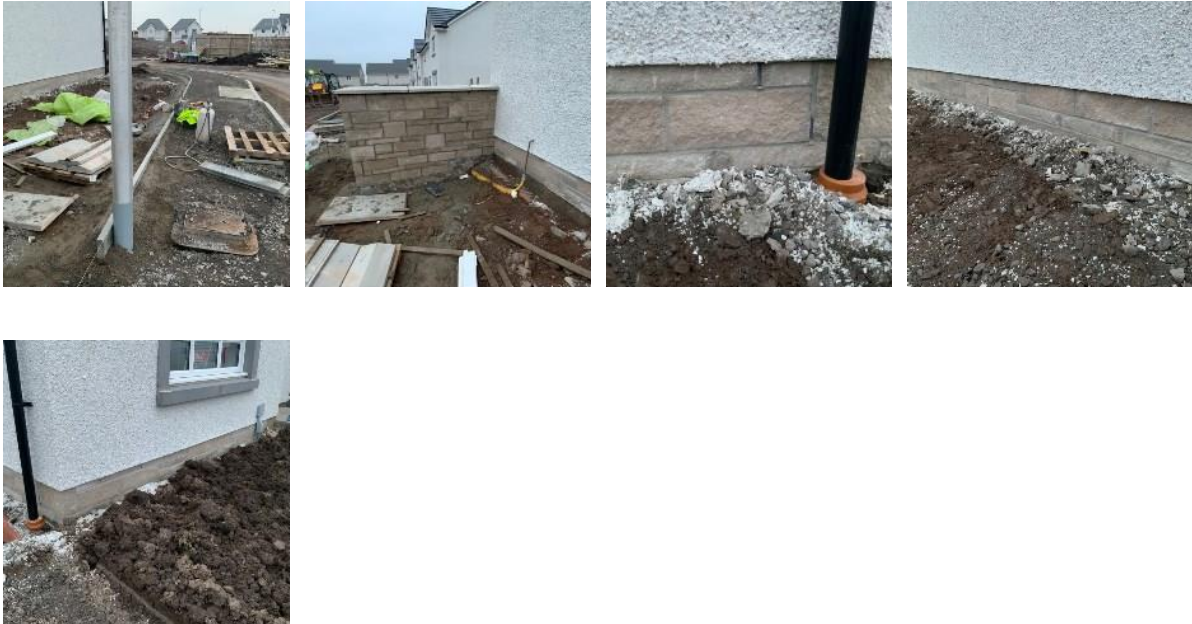
Unfinished footpath

Description: Footpath unfinished at the time of the visit, suitable falls to be maintained away from the home with surface course applied.

Perimeter Gravel strips should be cleared of construction debris to ensure a suitable uncompacted area to percolate water through suitable managed drainage.
